TECHNICAL BULLETIN: Schlage CO Series Mechanical Security Enhancement

Schlage CO Series

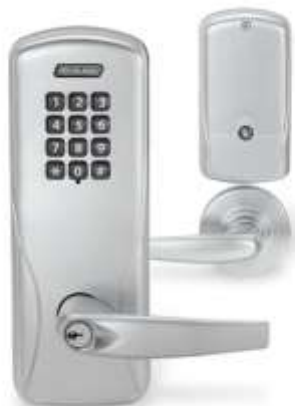
As part of our ongoing process to enhance the security of our products, we have developed a mechanical security enhancement for the Schlage CO Series. This enhancement is for the weep hole on the lower side of the external escutcheon (see picture below) and will not impact the intended function of the weep hole (i.e., allow water and moisture to escape).

Allegion created a retrofit clip that customers can field install to provide the mechanical security enhancement for installed units. We recommend that all commercial customers install this update. These retrofit clips can be obtained free of charge by calling our technical support line (1-877-671-7011, Option 2).
